**Inspection reference: 1000**

## **Confidential Inspection Report**

**1234 NW 1 St  
Miami FL 33166**

**May 31, 2017**

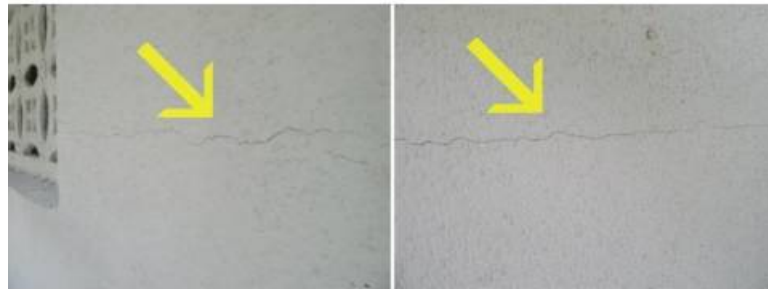
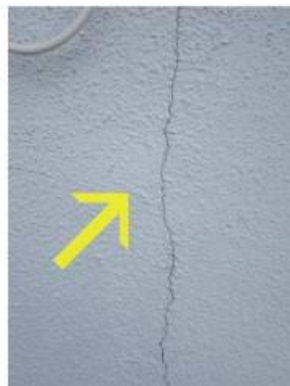
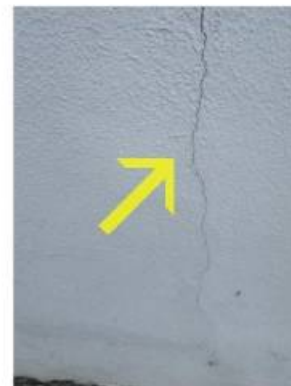
Concrete Block, Walls are constructed with Stucco. Minor settlement cracks are noted, None of the cracks appear significant. Any minor settlement or expansion cracks should be filled. Estimate for repairs \$ 350.00 +/-

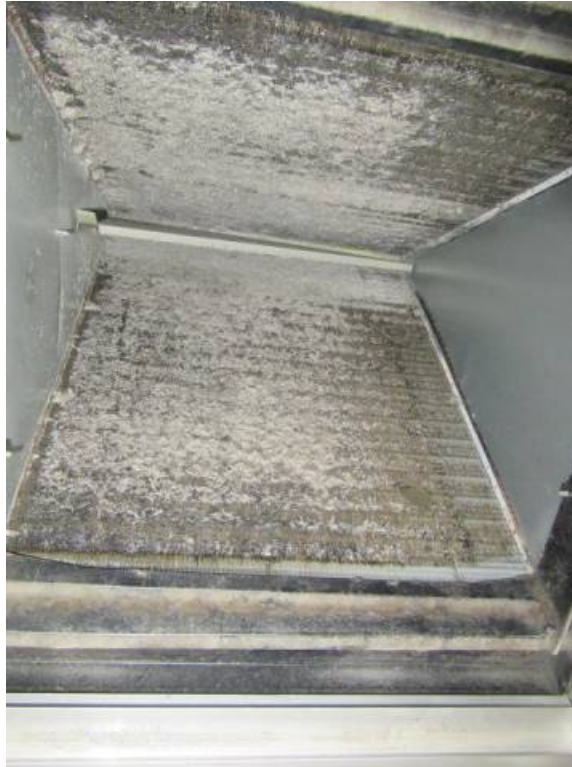
**Coils**

Unit is not producing an adequate air temperature drop. This may be due to excessively dirty coils. Have coils cleaned and unit serviced.

OK	MM	RR	
<i>Air Temp Drop:</i>	<input type="checkbox"/>	<input type="checkbox"/>	<input checked="" type="checkbox"/>	12 F Cooling not adequate.
<i>System Condition:</i>	<input type="checkbox"/>	<input type="checkbox"/>	<input checked="" type="checkbox"/>	Unit is not producing an adequate air temperature drop. This may be due to excessively dirty coils. Have coils cleaned and unit serviced.
<i>Condensate Line:</i>	<input checked="" type="checkbox"/>	<input type="checkbox"/>	<input type="checkbox"/>	Condensate line installed.
<i>Normal Controls:</i>	<input checked="" type="checkbox"/>	<input type="checkbox"/>	<input type="checkbox"/>	
<i>Comment:</i>	Units of this type typically have a service life of 10-15 years. As a condenser nears 10 years of age, it has an increased likelihood of breakdown in the future. Due to the age of the unit you should anticipate the need to repair/ replace in the near future.

<i>Air Conditioning:</i>	<input type="checkbox"/>	<input type="checkbox"/>	<input checked="" type="checkbox"/>	Coils are Dirty. Estimate to clean coils \$ 250.00 +/-.
--------------------------	--------------------------	--------------------------	-------------------------------------	---
