**Inspection reference: 1045**

**Confidential Inspection Report**  
**11111 Collins Ave Unit # 1**  
**Sunny Isles Beach FL 33160**

**July 25, 2017**

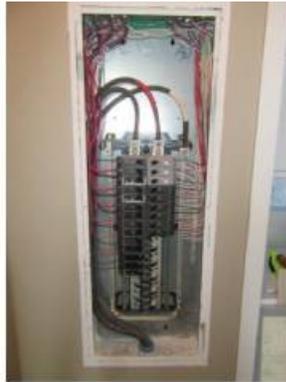
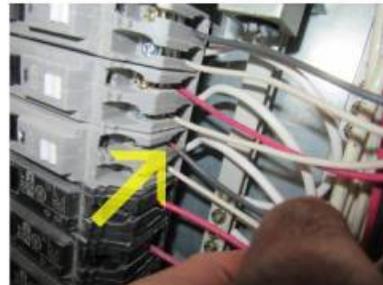
| <i>Main Panel Observations:</i> | <input type="checkbox"/> <input type="checkbox"/> <input checked="" type="checkbox"/> Damage/defects noted, loose/ Disconnected wiring is noted within the electrical distribution panel. Have a licensed electrician repair. Estimate for repairs \$250.00 plus or minus. |

Disconnected wiring is noted within the electrical distribution panel. Have a licensed electrician repair. Estimate for repairs \$250.00 plus or minus.

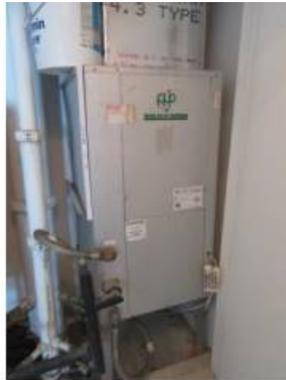
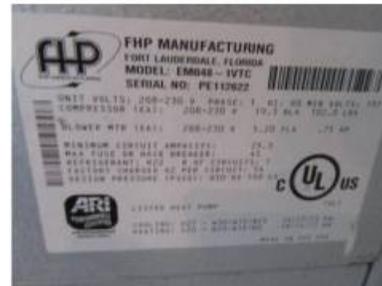
*Primary Type:* Central, Electric, water cooled unit.

*Brand:* FHP.

**Capacity / Approx. Age:**  
4.0 Tons, manufactured in 2006.

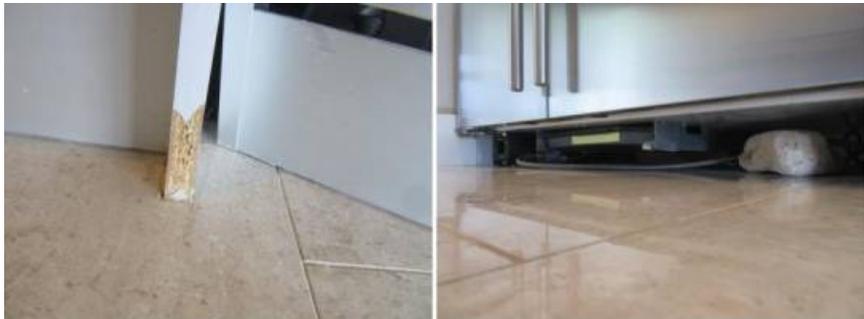
Condition:    There is minor damage on one base cabinet. Missing kick plate under refrigerator. Estimate for repairs \$250 plus or minus.

There is minor Formica damage on one base cabinet. Missing kick plate under refrigerator. Estimate for repairs \$250 plus or minus.

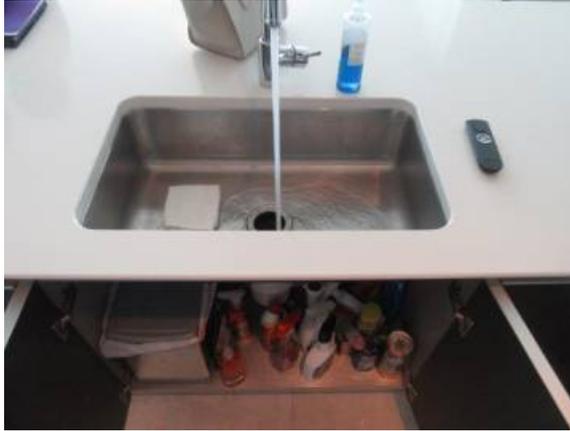
**Sink:**

*Fixtures & Drain* OK MM RR  
   Stainless Steel.

*Condition*    Tested working properly at time of inspection.

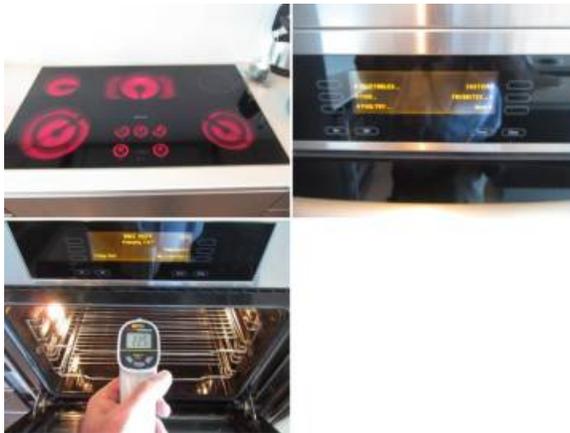
**Range/ Cooktop / Oven:**

*Type & Condition:*    Separate cook top, Tested working properly at time of inspection.

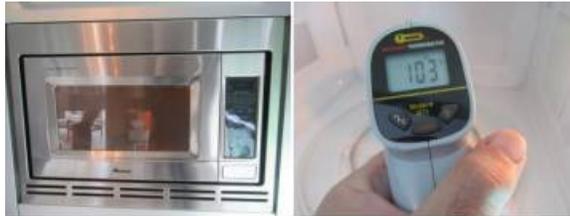
**Other Built-ins:**

*Microwave:*    Tested working properly at time of inspection.

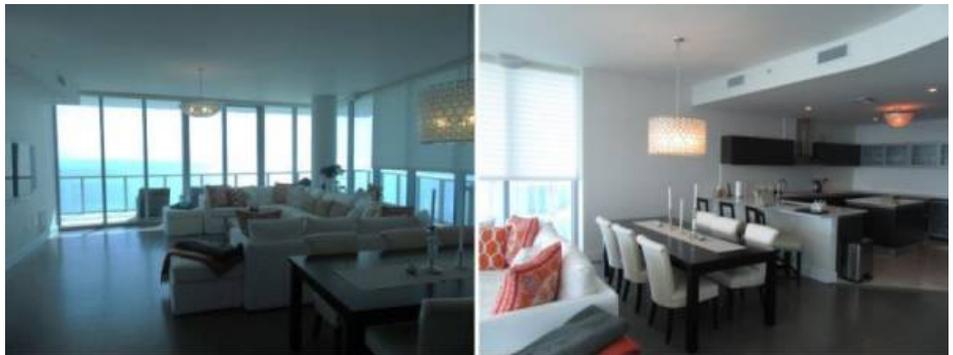
**Living / Dining Room/Family Room:**

Door locking hardware needs some adjustment or repair for it to function appropriately. It will not latch. Estimate \$50 plus or minus.

Door locking hardware needs some adjustment or repair for it to function appropriately. It will not latch. Estimate \$50 plus or minus.

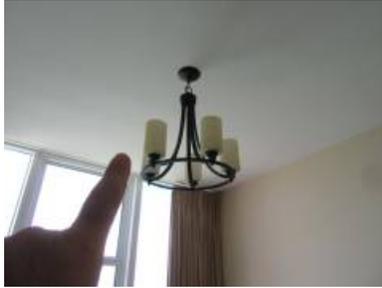
Outlets do not function in bedroom 2. This is likely a direct result of the loose wire in the electrical panel.

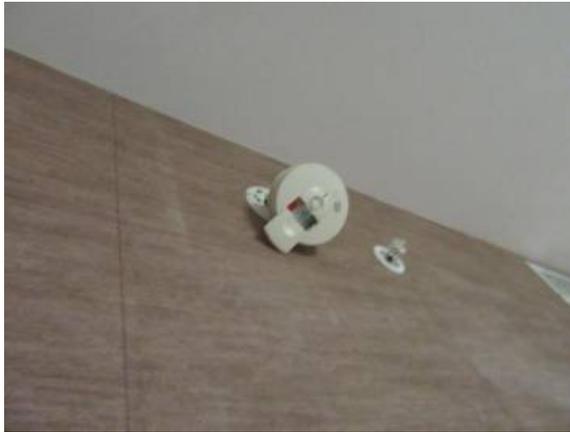
Smoke detectors disconnected in master bedroom, this is a potential safety hazard. Recommend replacement estimate \$75 plus or minus.

Smoke detectors disconnected in master bedroom, this is a potential safety hazard. Recommend replacement estimate \$75 plus or minus.

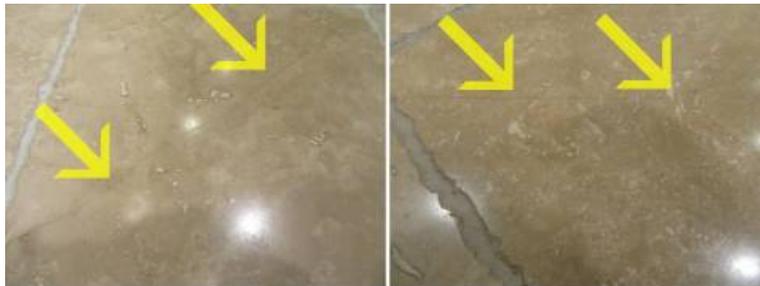
The floor covering material is tile. There are some minor hairline cracks present on tile flooring.

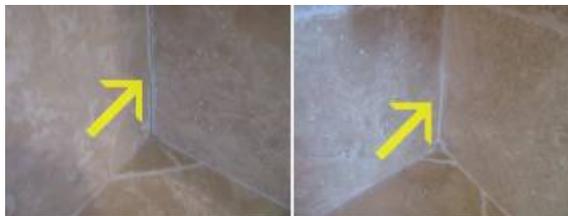
Caulk and seal all tub and shower areas . Estimate \$75 plus or minus.

Caulk and seal all tub and shower areas . Estimate \$75 plus or minus.

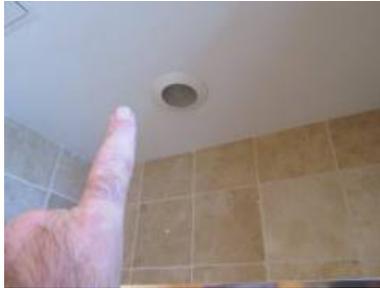
Switches & Fixtures:    The light installed over the shower did not function using the wall switch.

I did not determine if the switch is bad or if the light bulb is bad. Change bulb and test prior to closing.

The light installed over the shower did not function using the wall switch. I did not determine if the switch is bad or if the light bulb is bad. Change bulb and test prior to closing.

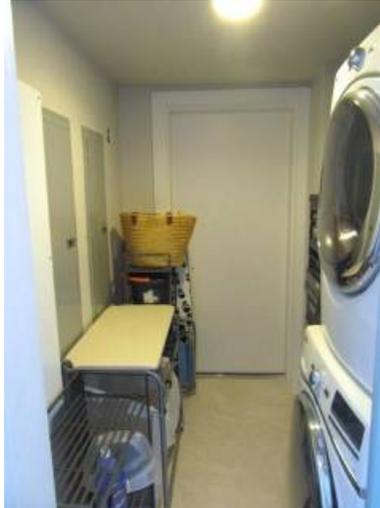
## Laundry:

Location: Closet.

OK MM RR    Located behind washer and dryer, not visible for inspection. Visible by picture only.

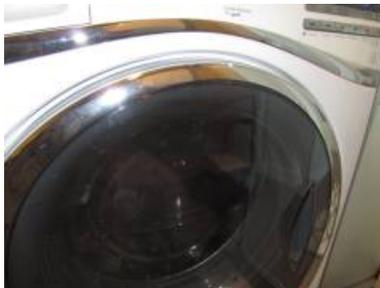
Clothes Washer:

Satisfactory, tested working properly at time of inspection.

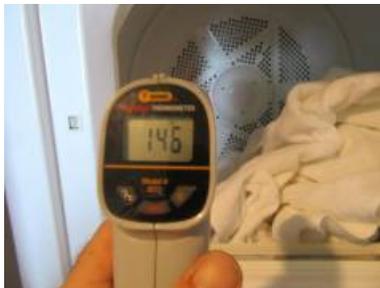
Clothes Dryer:

Satisfactory, tested working properly at time of inspection.
