**Inspection reference: 1000**

## **Confidential Inspection Report**

**1234 NW 1 St  
Miami FL 33166**

**May 31, 2017**

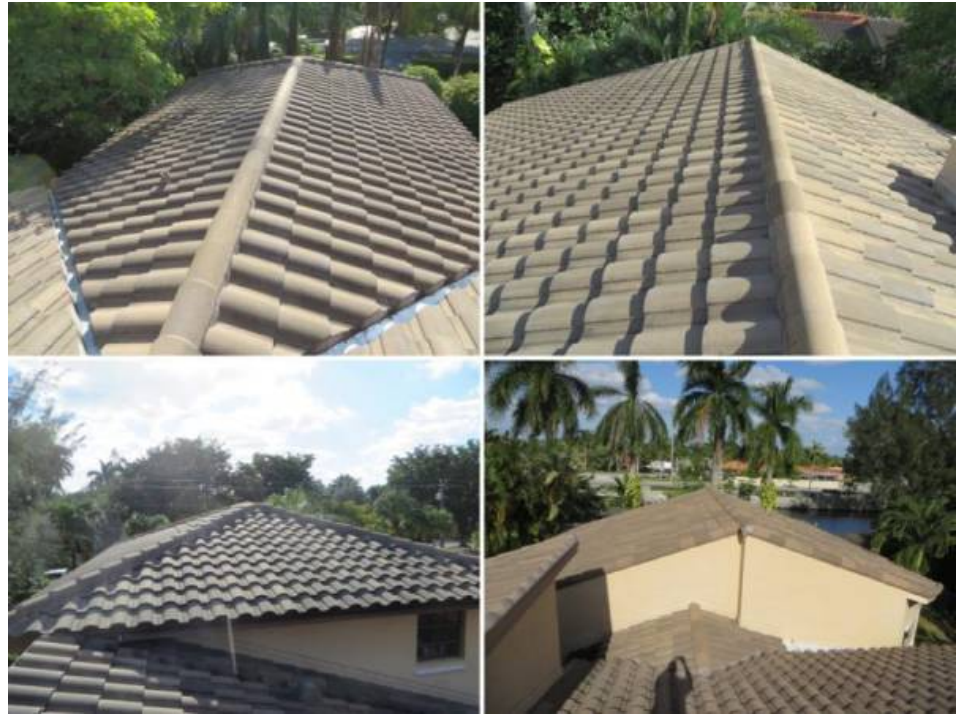
**Estimated Age** Per online building permit roof was replaced in 2010.

**Estimated Life Expectancy** 15 Years +/-

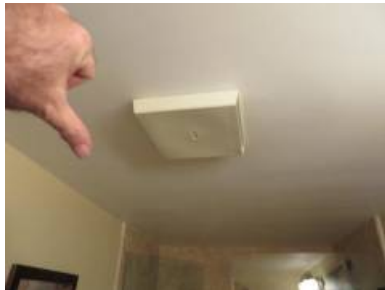
OK	MM	RR	
Tub/Shower Fixtures:	<input checked="" type="checkbox"/>	<input type="checkbox"/>	<input type="checkbox"/>	
Tub/Shower And Walls:	<input checked="" type="checkbox"/>	<input type="checkbox"/>	<input type="checkbox"/>	
Bath Ventilation:	<input type="checkbox"/>	<input type="checkbox"/>	<input checked="" type="checkbox"/>	Exhaust fan did not operate. Replacement needed. Estimate \$ 150.00 +/-
